EXTERNAL FAÇADE REPORT

CASTLE EXCHANGE

41 BROAD STREET, NOTTINGHAM, NG1 3AP

Report Number: DB/2404/06092020 REV A

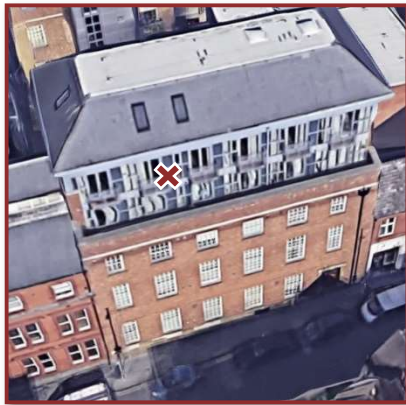
1A

8.1.2.1 Area 1 was an intrusive inspection undertaken to the external spandrel panel on the 4th-floor of the North facing elevation (see photo 1A).

8.1.5.2 Due to the existence of the PIR rigid insulation within the spandrel panel, the spandrel panel should be removed and replaced with a suitable alternative which achieves Euroclass A2 or better or a BR135 classification via a BS8414-2 test, in accordance with the advice contained within the MHCLG Guidance and to ensure compliance with Building Regulation B4 (1).

8.1.6.1 Due to the presence of combustible PIR foam insulation behind the spandrel panels, we concur with the findings of the FRC report, and our advice is that the system should be removed and replaced with a system of materials rated to Euroclass A2 or better.

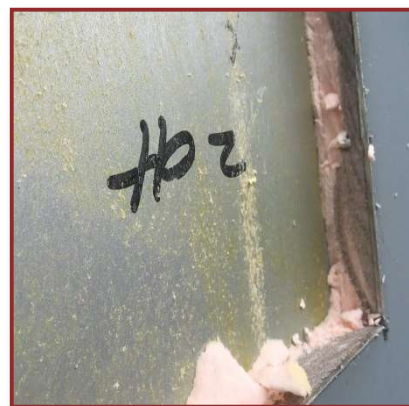
1D

8.1.2.2 The spandrel face was found to be a 2mm aluminium product that has been applied to 25mm thick PIR rigid foam insulation, (see photo 1D) which was mounted to the structure within the curtain walling system. (see figure 1).

8.1.2.3 Behind the PIR insulation was a second 2mm aluminium plate (see photo 1D). The operative did not take the drill test any further due to the possibility of damaging the internal wall of the apartment.

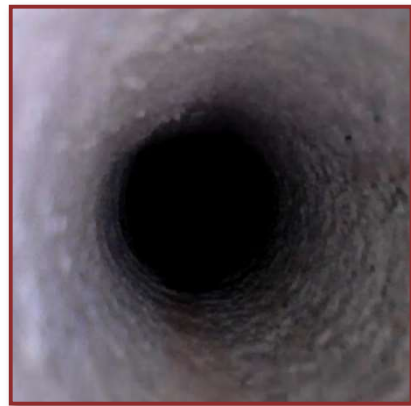
8.2.2.2 The construction was found to be a Flemish bond, solid brickwork, the drill test was terminated at 300mm (*see photos 2D and 2E*).

8.2.5.1 Due to the solid masonry construction and the absence of any materials of a combustible nature, there are no recommendations within this location

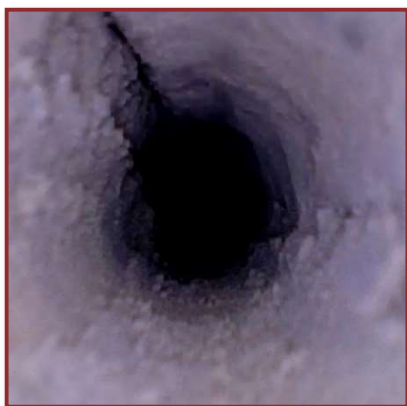
8.3.2.2 The construction was found to be a Flemish bond 240mm brickwork (*see photo 7D*) which was in front of a 110mm empty cavity ahead of the internal blockwork wall (*see photos 3C and 3D*).

8.3.5.1 Due to the solid masonry construction and the absence of any materials of a combustible nature, there are no recommendations within this location

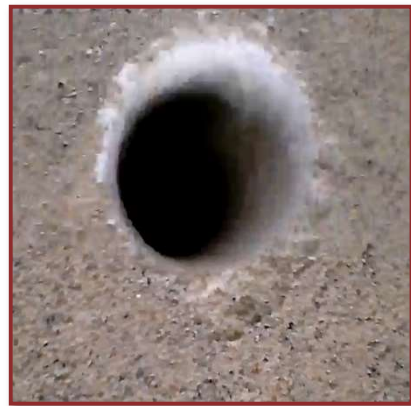
8.6.2.2 The construction was found to be 100mm masonry Quoin detail (*see photos 6D and 6E*) which was in front of a 160mm empty cavity to 40mm PIR rigid foam insulation (*see photo 6G and 6J*) ahead of another 100mm empty cavity to the internal plasterboard wall (*see photo 6I*).

8.6.5.2 Should the risk not be acceptable, it is recommended that the insulation is removed and replaced with a system that is of limited combustibility, or that additional fire resisting boarding is installed internally to further encase the combustible material.

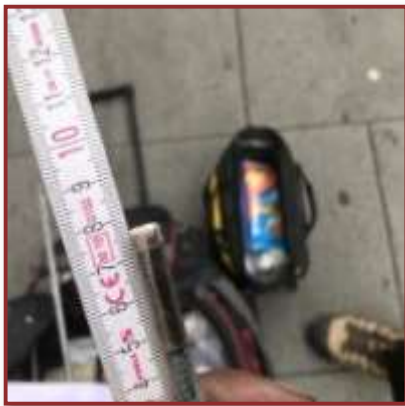
7C

8.7.2.2 The construction was found to be a 75mm masonry (*see photo 7C*) which was in front of a 70mm empty cavity to 30mm PIR rigid foam insulation ahead of another 100mm empty cavity to the internal plasterboard wall.

8.7.5.2 Should the risk not be acceptable, it is recommended that the insulation is removed and replaced with a system that is of limited combustibility, or that additional fire resisting boarding is installed internally to further encase the combustible material.

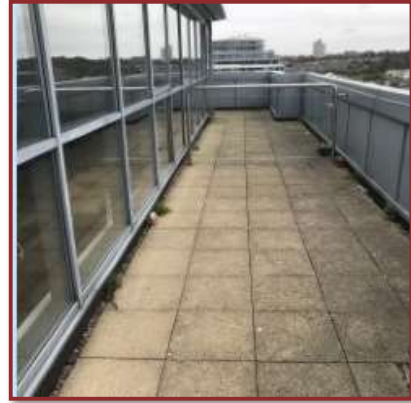
8B

8.8.2.3 The floor of the roof terrace we assume was a poured concrete slab which had been decked with 450 x 450mm concrete paving slabs (*see photo 8B*). The operative noted the paving slabs were on legs sitting on blue insulation (*see photo 8F*). The insulation was not identified and will require further investigation.

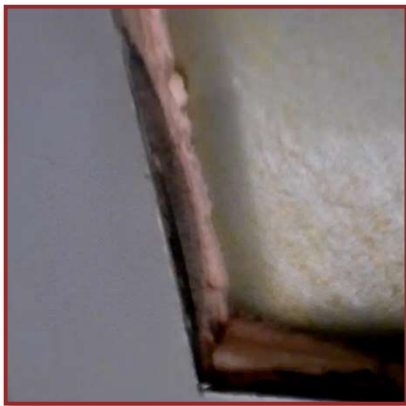
9C

8.9.2.2 The spandrel face was found to be a 1mm Aluminium has been applied to 100mm thick expanded rigid (PIR) insulation with a second layer of aluminium to the rear, which was mounted to the structure using an aluminium rail system (*see photos 9C, 9D and 9F*).

8.9.5.2 Should the risk not be acceptable, it is recommended that the insulated panels are removed and replaced with a system that is of limited combustibility, namely that with achieves a combustibility rating of Euroclass A2 or better.

- 8.9.6.1 Due to the presence of combustibile PIR foam insulation behind the spandrel panels, we concur with the findings of the FRC report, and our advice is that the system should be removed and replaced with a system of materials rated to Euroclass A2 or better.

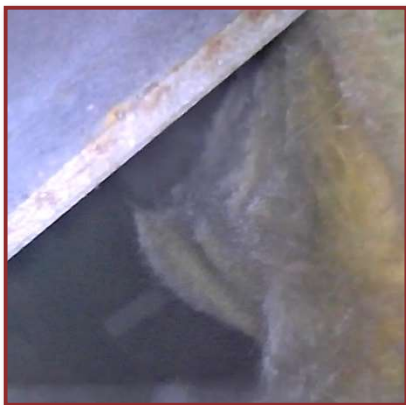
9G

8.9.2.3 Behind the spandrel system is an empty cavity with a small amount of mineral wool insulation (*see photo 9G*), to the internal timber plyboard sheeting . **See figure 2 below.**

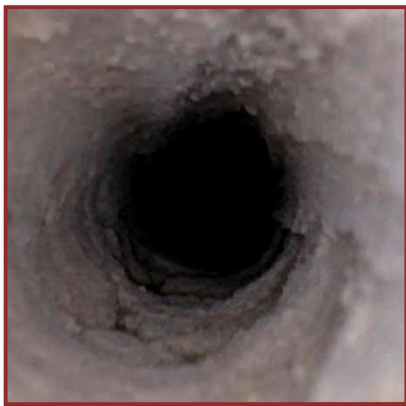
10C

8.10.2.2 The construction was found to be 100mm brickwork (*see photo 10C*) which was in front of a 230mm empty cavity ahead of the internal plasterboard (*see photo 10D*).

8.10.5.2 Should the risk not be acceptable, it is recommended that the insulation is removed and replaced with a system that is of limited combustibility, or that additional fire resisting boarding is installed internally to further encase the combustible material.

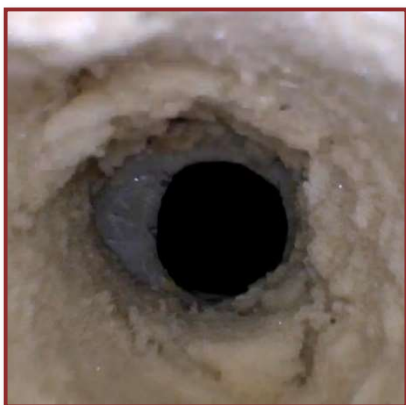
8.10.2.3 A secondary hole was drilled on the section above the brickwork within the aluminium the curtain walling section (*see photo 10E*). The construction was found to be 1mm aluminium sheeting with an internal core of PIR rigid foam insulation with a final layer of aluminium (*see photo 10F*). This was in front of a 315mm empty cavity to the internal plasterboard (*see photos 10G and 10H*).

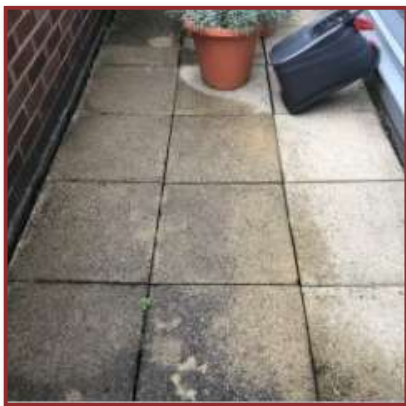
11C

8.11.2.3 The floor of the roof terrace we assume was a poured concrete slab which had been decked with 450 x 450mm concrete paving slabs. The operative noted the paving slabs were on legs sitting on blue insulation (*see photo 11C*). The insulation was not identified and will require further investigation.

8.11.5.2 Should the risk not be acceptable, it is recommended that the decking is removed and replaced with a product that is of limited combustibility or better.

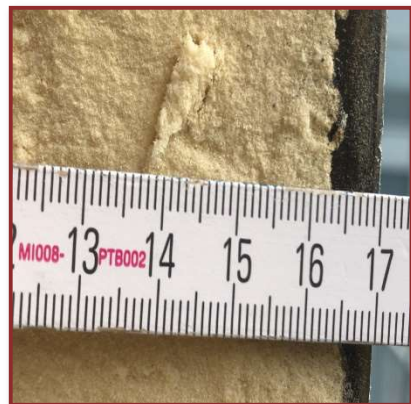
8.12.2.2 The face was found to be an aluminium sheet that has been applied to 65mm thick PIR rigid insulation, with a second aluminium plate to the rear, which was mounted to the structure using an aluminium rail system running vertically (*see photos 12C, 12D and 12G*).

8.12.5.2 Should the risk not be acceptable, it is recommended that the insulated panels are removed and replaced with a system that is of limited combustibility, namely that with achieves a combustibility rating of Euroclass A2 or better.

8.12.6.1 Due to the presence of combustible PIR foam insulation behind the spandrel panels, we concur with the findings of the FRC report, and our advice is that the system should be removed and replaced with a system of materials rated to Euroclass A2 or better. The spandrel panel combined with PIR insulation

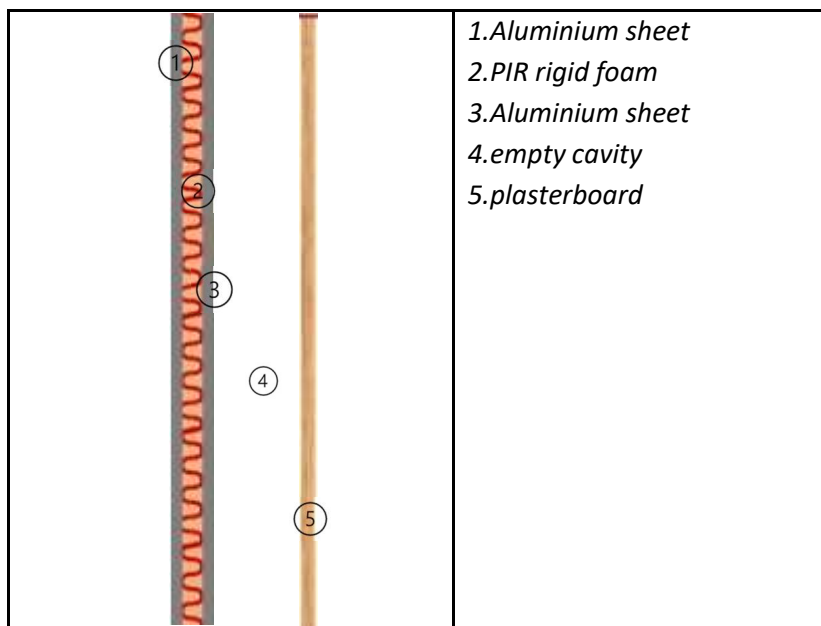
Figure 3

8.12.2.4 There was no evidence of proprietary fire barriers within the cavity during the inspection, however the galvanised carrier rail took up the whole of the cavity on both sides (*see photo 12G*). *Refer to figure 3 below.*
