EXTERNAL FAÇADE REPORT

CASTLE EXCHANGE

41 BROAD STREET, NOTTINGHAM, NG1 3AP

Report Number: DB/2404/06092020 REV A

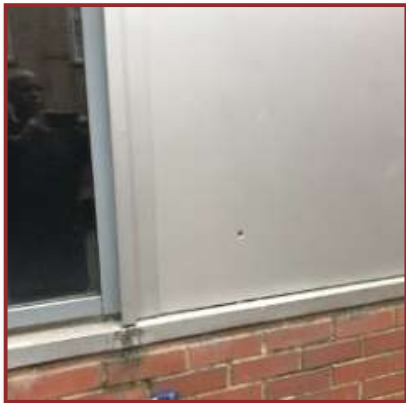
10E

8.10.2.3 A secondary hole was drilled on the section above the brickwork within the aluminium the curtain walling section (*see photo 10E*). The construction was found to be 1mm aluminium sheeting with an internal core of PIR rigid foam insulation with a final layer of aluminium (*see photo 10F*). This was in front of a 315mm empty cavity to the internal plasterboard (*see photos 10G and 10H*).

8.10.5.2 Should the risk not be acceptable, it is recommended that the insulation is removed and replaced with a system that is of limited combustibility, or that additional fire resisting boarding is installed internally to further encase the combustible material.

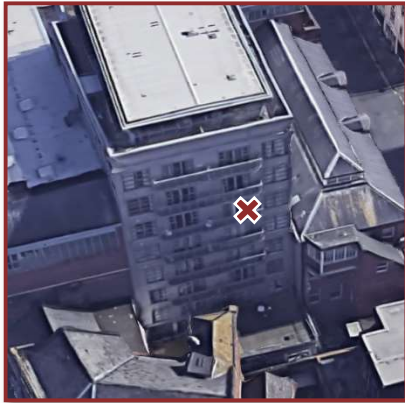
13A

8.13.2.1 Area 13 was an intrusive inspection undertaken to the Insulated panel on the fourth-floor South facing elevation (**see photos 13A**).

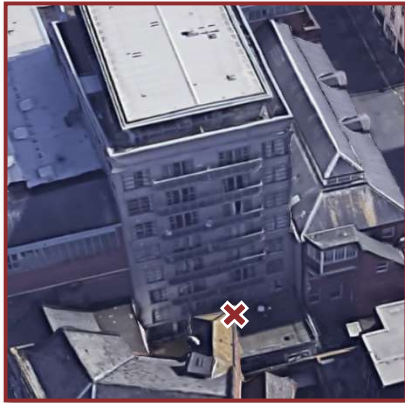
14A

8.14.2.1 Area 14 was a non-intrusive visual inspection carried out to the 3rd floor cantilever balcony on the South facing elevation (*see photo 14A*).

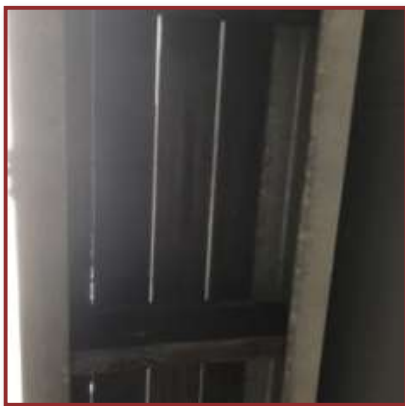
14C

8.14.2.3 The floor of the Balcony which had been decked with Timber decking with a timber mid span support (*see photo 14C*).

12.4.1 There was evidence of timber balcony decking, which is combustible and therefore, recommended for removal by FRC and within the MHCLG guidance.
